Performance Audit  
Report No. 2 of  
2018

# Management of Gamodubu Landfill

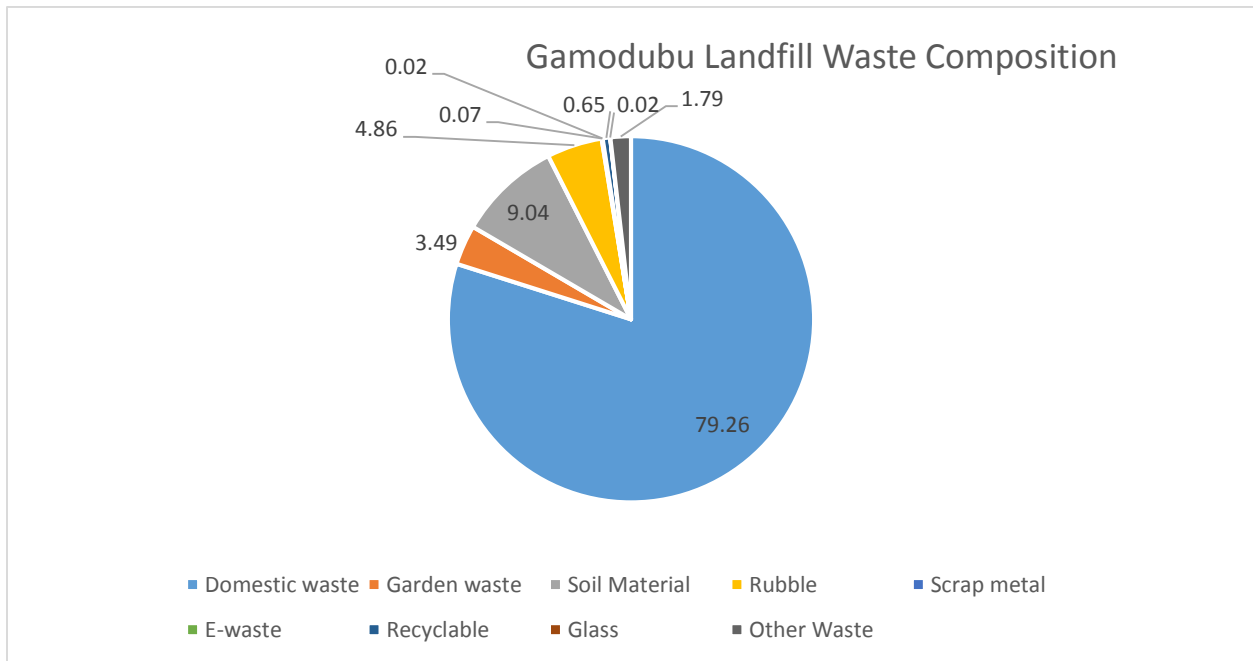
**Figure 1: Composition of waste disposed of at Gamodubu landfill (2009-2014)**

The Gamodubu Landfill receives controlled waste which includes among others; general waste, clinical, scrap metal, tyres, garden waste and building rubble. The waste composition at the Gamodubu Landfill, during the period 2009 – 2014, is shown in **Figure 1** below;

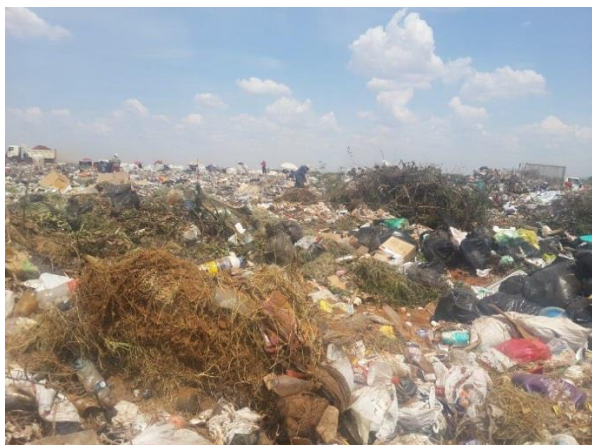
**Figure 3: Garden waste at the general waste cell**

As a result of the inadequate inspection of incoming waste, the waste ended up being deposited at the wrong waste cells. This was corroborated by an interview with the Landfill Operatives who highlighted that the inadequate waste inspection by the Enumerators led to waste not earmarked to general waste cells being there, such as tyres, florescent bulbs and metals. This therefore, made it difficult for them to adequately compact waste. During an inspection of the general waste cells by the Audit Team, it was found that there were tyres, garden waste as well as some metals in the general waste cell as evidenced by **Figure(s) 3** and **4** below. However, it is worth noting that the disposal of whole tyres in the landfill can contribute to “surface instability and present a fire risk with the potential for excessive black smoke”<sup>24</sup>

- **Appropriate Guidelines on how best waste can be inspected upon entering the landfill are developed for consistency and accountability thus preventing environmental pollution.**
- **Weighbridge operators are provided with proper protective clothing for protection against the spread of diseases and serious injuries that come with improper waste handling.**

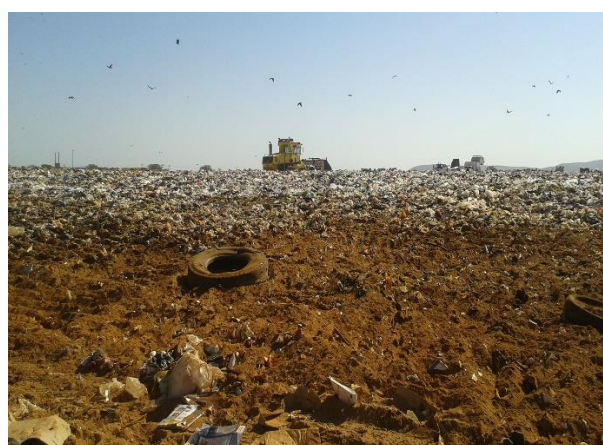
**Figure 4: Tyres disposed at the general waste cell**

Documents reviewed indicated that tyres if deposited whole in a landfill can rise and cause void spaces which break the surface and encourage vermin.

Moreover, they could also contribute to surface instability and present a fire risk with the potential for excessive black smoke.<sup>39</sup>

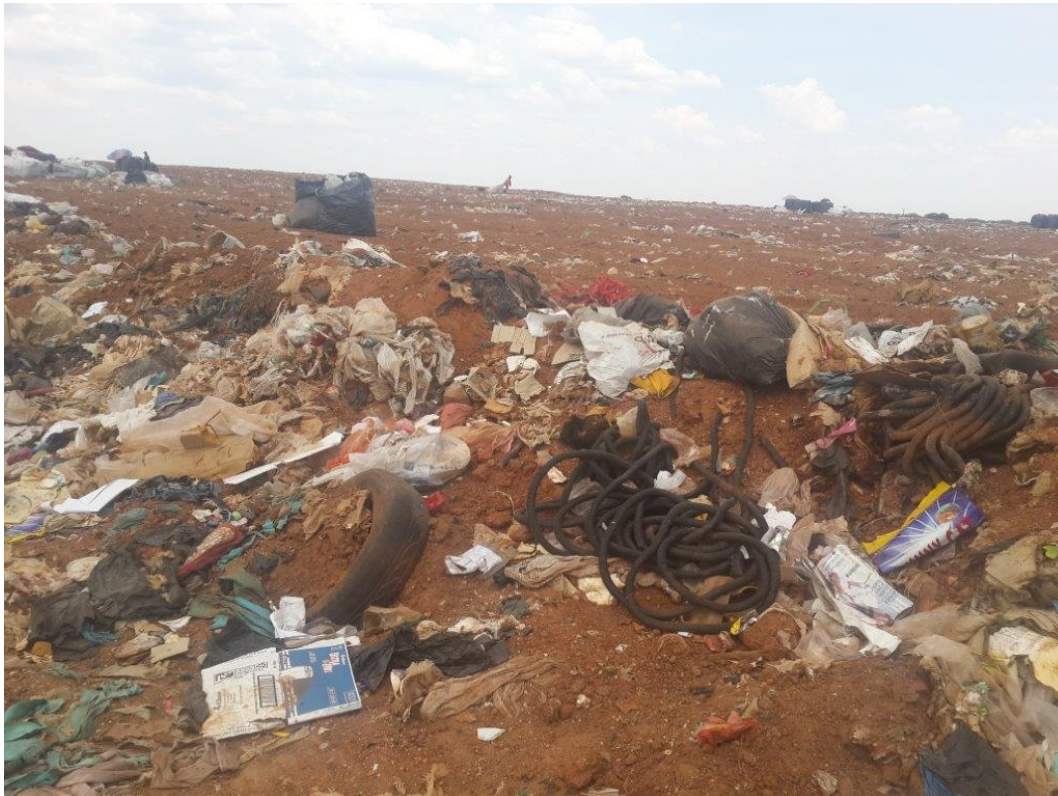
**Figure 6: Waste said to have been compacted**

Moreover, interviews with the Gamodubu residents on the 23 January 2015 and 24 January 2015 revealed that there were times when they experienced odour and flies in the village due to inadequate compaction and covering of waste

at the landfill. The residents contended that the landfill Management was not doing enough to reduce the instances of odour and flies which affected their livelihood as it led to their homes being inhabitable. The odour from the waste may also lead to occupational hazard to the landfill workers working at the landfill and also attract the scavengers to enter and obtain contaminated foodstuff which might be hazardous to their lives.

*"The landfill guidelines are followed. However, the nature of waste especially plastic and plastic coated boxes are difficult to handle as they are not easily compactable and are not biodegradable as compared to waste. Additionally the cover material is prone to being blown away and expose the waste as vehicles go over waste. The Council has procured the wooden profiles that will be painted and marked to direct the Plant Operator during compaction" as measurement tools. Moreover, the Department had awarded a Plant Hire tender to Red & White (PTY) LTD which is currently on site (2017/18). In addition, the Council has extended the working hours for Truck Drivers and Plant operators during weekends and public holidays from 1330hrs to 1630hrs to rescue the situation".*

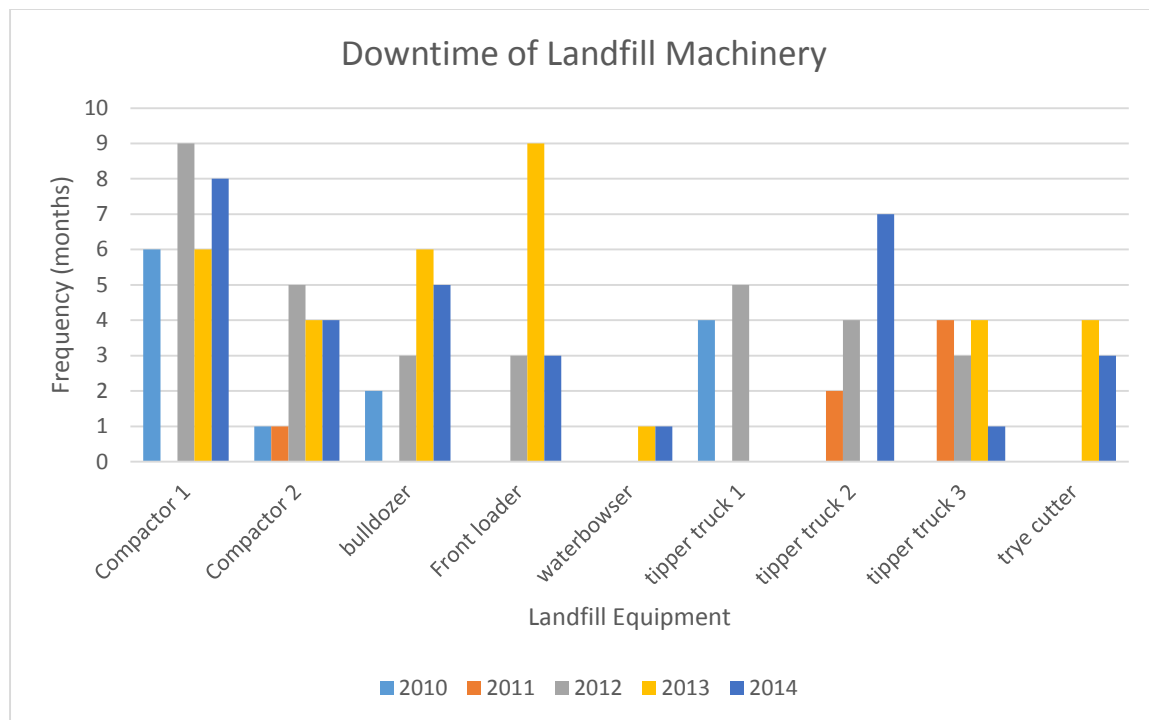
**Figure 7: Downtime of Landfill Machinery, 2010 – 2014**

facility to operate accordingly. The downtime for the landfill equipment and machinery over the years is presented in the graph overleaf;

Documents reviewed and interviews highlighted that the following were contributory factors for the delay to repair the equipment;

- There was inadequate capacity to maintain machinery, in terms of number and expertise. For instance, there was only one (1) mechanic responsible for Kweneng District Council machinery, despite the vastness of the District.
- Moreover, landfill management stated that some of the parts required to service the landfill equipment, especially compactors had to be sourced outside the country which exacerbated long procurement process.

Equipment and machinery that remain stationary for extended periods of time without being maintained often suffer further damages as they tend to deteriorate. Such deterioration will end up costing the Council and the Government exorbitant maintenance costs in the long run and lead to problems that may otherwise expedite their complete breakdown. Furthermore, continuous breakdown of equipment and machinery inhibited the Environmental Health Unit's service delivery that led to uncontrolled nuisances in the landfill. This negatively affected the ability of the landfill management to manage the landfill sustainably.

- **Ensure that equipment is constantly repaired and maintained to enhance their capacity and availability.**
- **Device a plan which will ensure timely purchase of spare parts instrumental in timely maintenance of machinery.**
- **Develop timelines (lead times) for procurement of equipment spare parts and ensure that they are strictly adhered to.**
- **Review the appropriateness of the existing spare parts policies and streamline it to suit the present spare parts scenario.**

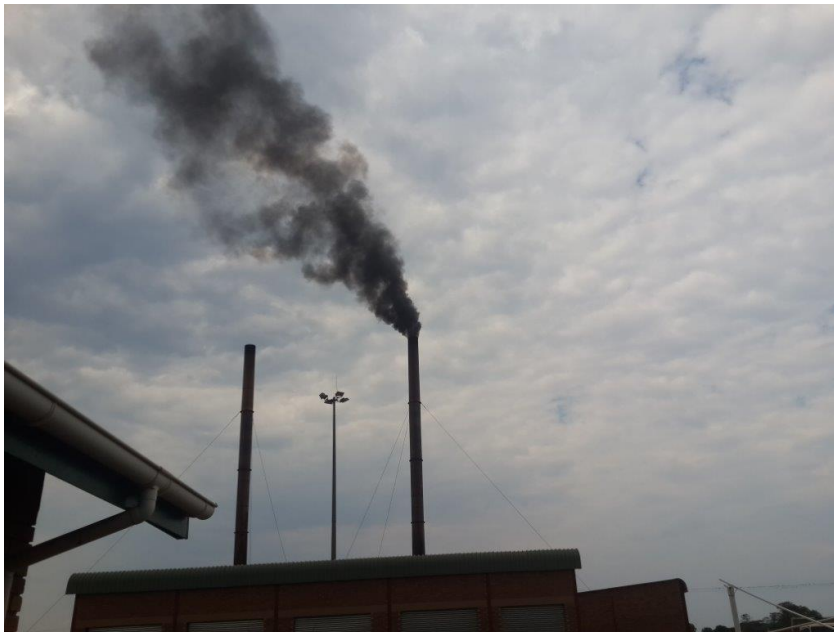
**Figure 8: Incinerator Emission**

black smoke as evidenced by **Figure 8** hereunder and might have also emitted dioxins, thus having impact on the environment. <sup>33</sup>

Interviews conducted showed that the landfill incinerators had not been appropriately maintained. This was further substantiated by documents reviewed which revealed that the incinerators were “long overdue for replacement of fly ash arrestors and lining of internal walls, as they were worn out” (Refer to **Figure 9** for details).<sup>34</sup> Consequently, these “contributed to factors to the emission of respirable particulars from the chimneys which in the long run will affect the health of the employees.”<sup>35</sup> Additionally, the incinerator gas emissions had not been tested, to assess the extent of toxicity of the gases emitted into the atmosphere contrary to the requirements of the Atmospheric Pollution Prevention Act. The contributory factor for the anomaly was said to be that “the sampling ports had not been installed in the incinerators, from the onset (design problem)”.<sup>36</sup>

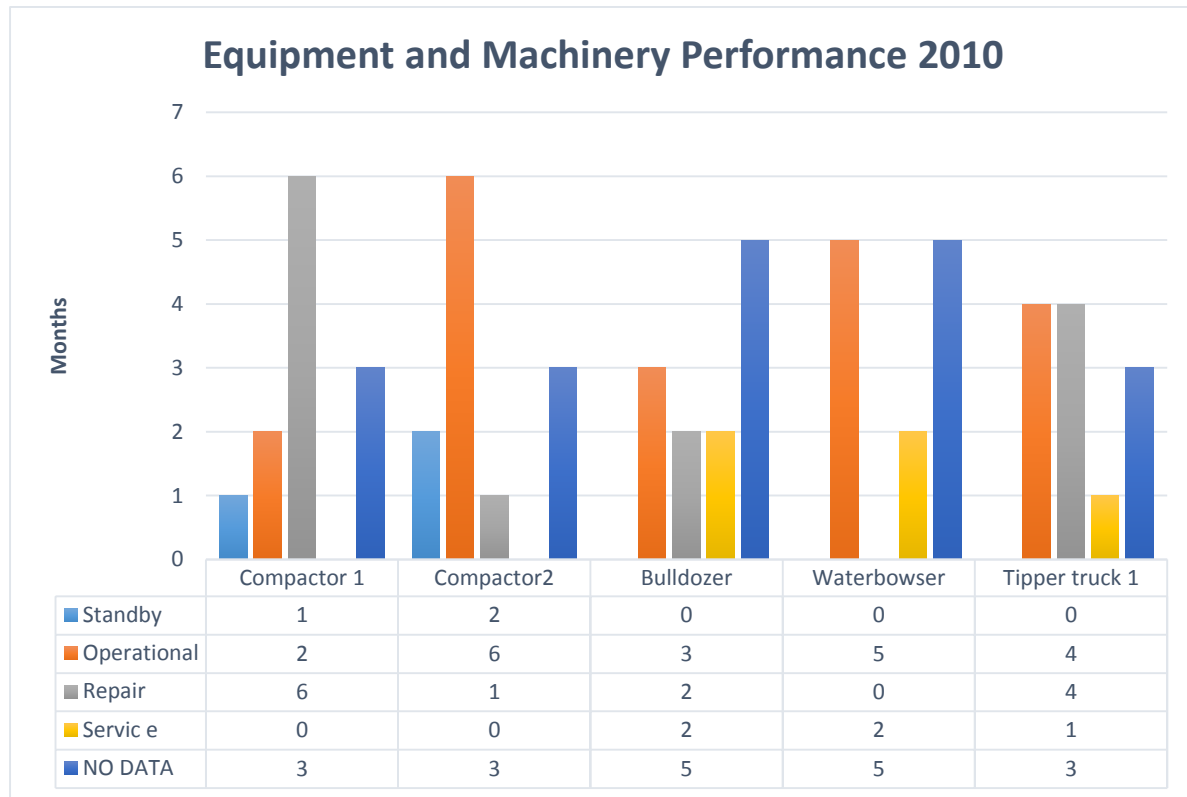
**Figure 1: Landfill Equipment and Machinery Performance, 2010**

The chart shows that for the year 2010, Compactor 2 operated for 6 months, while other equipment was operational for 5 months or less. The analysis also shows that Compactor 1 was under repair for six (6) months in the year under review, while other equipment were under repair for four (4) months or less. There was no data provided to the auditors on the status of the landfill equipment (Bulldozer and Waterbrowser) for five months and three months (Compactor 1, Compactor 2 and Tipper Truck 1) respectively.

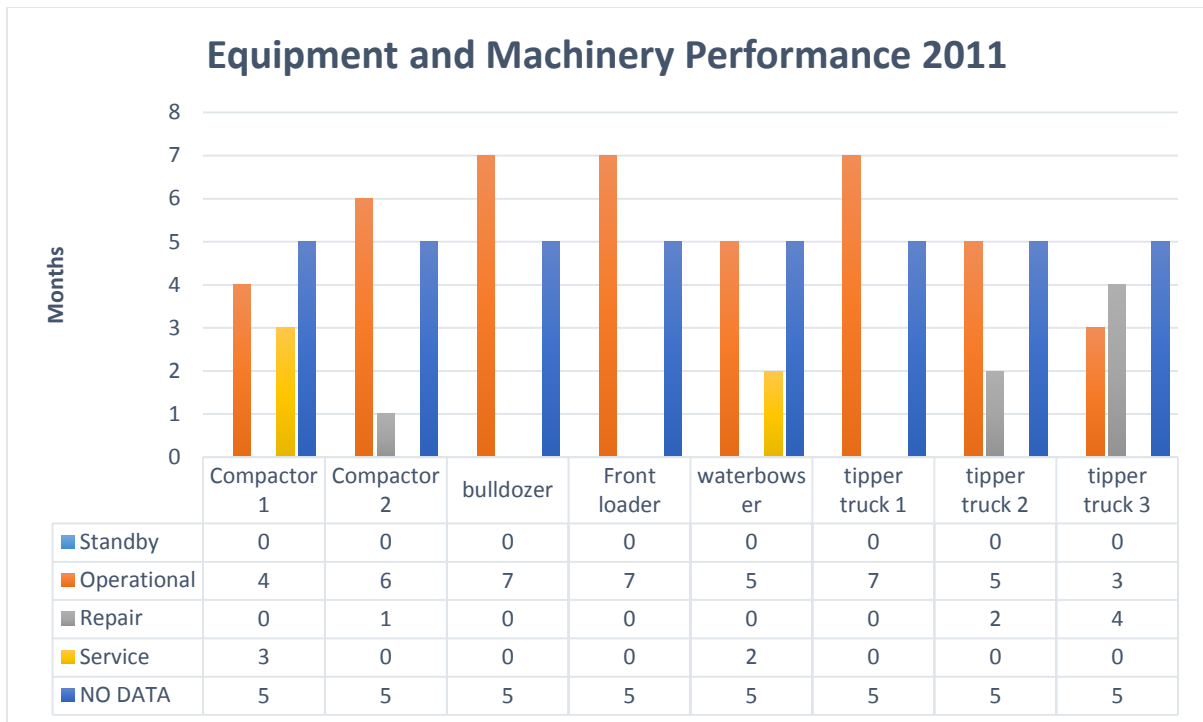
**Figure 2: Landfill Equipment and Machinery Performance 2011**

The chart shows that the landfill equipment was operational most of the time in the year 2011. However, this was with the exception of Tipper truck 3 and Compactor 1 which were operational for less than 40% of the time in a year. In addition, there was no data provided to the auditors on the status of the equipment for months starting from January to May 2011.

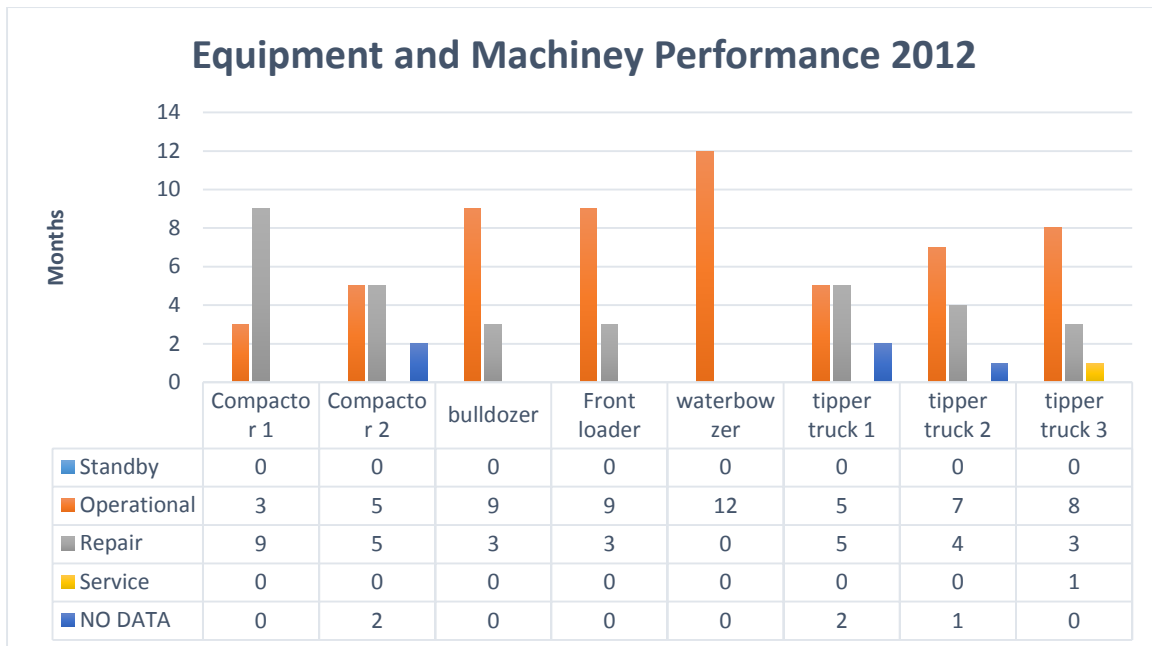
**Figure 3: Landfill Equipment and Machinery Performance 2012**

The analysis of the data shows that both compactors and tipper truck 1 were operational for less than six (6) months in the year under review. However, other landfill equipment such as bulldozer, front loader, waterbowser, tipper truck 2 and tipper truck 3 were operating for seven or more months. The chart also shows that compactor 1 spent most of the time (nine months) under repair while compactor 2 and tipper truck 1 were under repair for five months respectively.

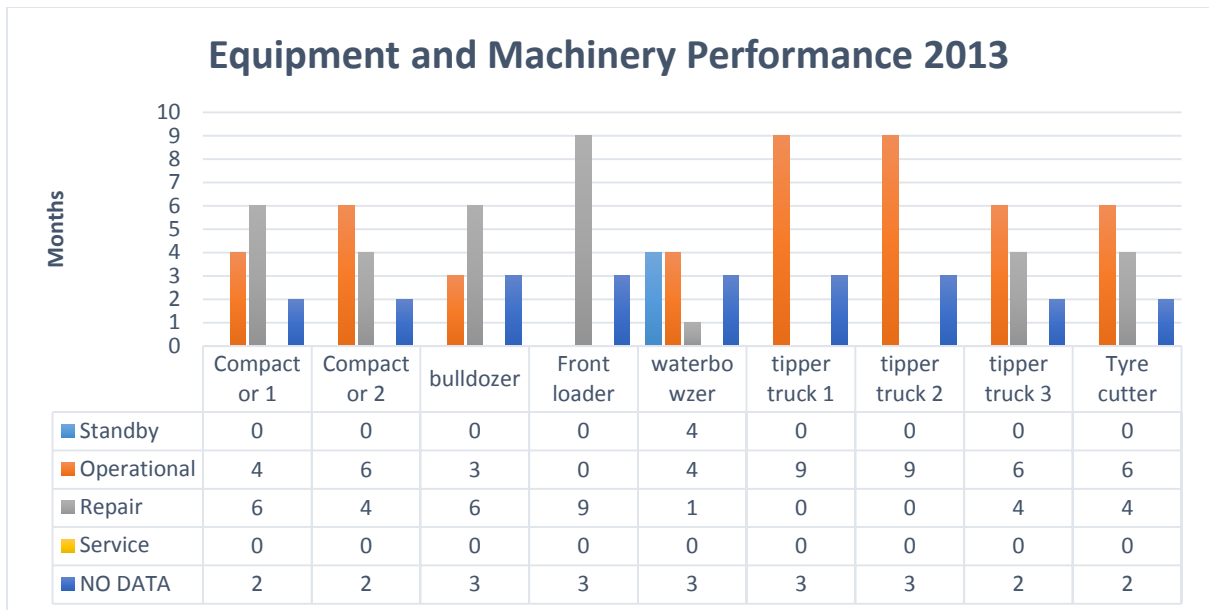
**Figure 4: Landfill Equipment and Machinery Performance 2013**

The analysis of the chart depicts that compactor 2, tipper truck 1, tipper truck 2, tipper truck 3 and tyre cutter were operational for more than six (6) months in a year. However, compactor 1, bulldozer and water bowser were operating for less than 50% of the time. Moreover, compactor 1, bulldozer and front loader spent 50% or more of the time under repairs.

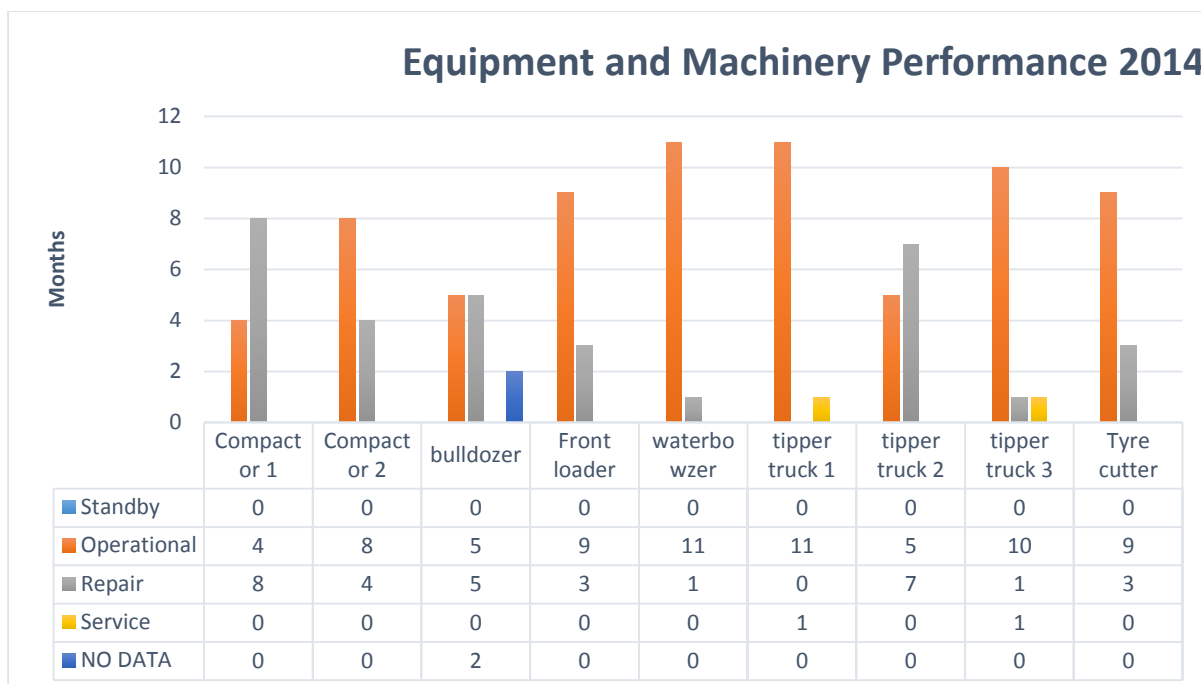
**Figure 5: Landfill Equipment and Machinery Performance 2014**

The chart shows that most of the landfill equipment were operational for eight months or more in the year 2014. However, this is with the exception of compactor 1 (four months), bulldozer (five months) and tipper truck 2 (five months). The chart also shows that compactor 1 and tipper truck 2 spent a considerable amount of time under repairs with compactor 1 having spent eight months and tipper truck 2 spending seven months. Other equipment which spent some time under repairs included ; compactor 2 (four months), bulldozer (5 months), front loader (three months), tyre cutter (three months) water bowser and tipper truck (one month) respectively.
